# Influence of Fastener Coating on Corrosion Behavior of Thixomolded Magnesium

Authors: Diptak Bhattacharya, Yoojin Kim, Andrew Bobel, Mary Gilliam, Michael Lukitsch, Congjie Wang, David Kies, Steven Kwong, Steven Cipriano, Carl Cadieux, Ulli Haus, Todd Garza

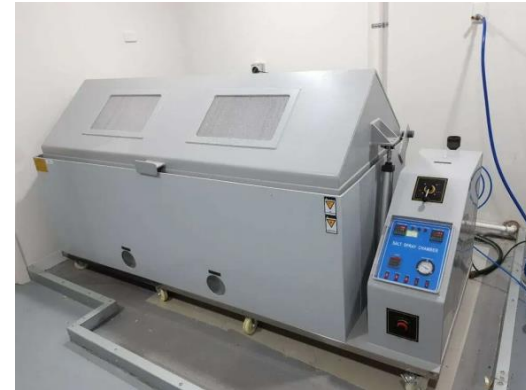
Salt Spray for 240 hrs.

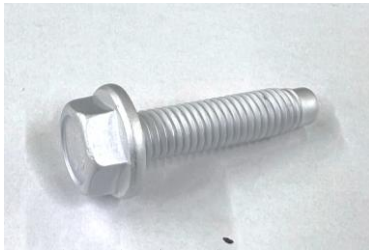
M8 hex head bolts with nominal diameter of 8 mm and pitch diameter of 1.25 mm

Al-plated (w/Ni)
