# Challenges for Test-to-Field Correlation in Automotive Corrosion Testing

**Bill Price**  
**GMNA Corrosion Engineering**  
**May 2026**

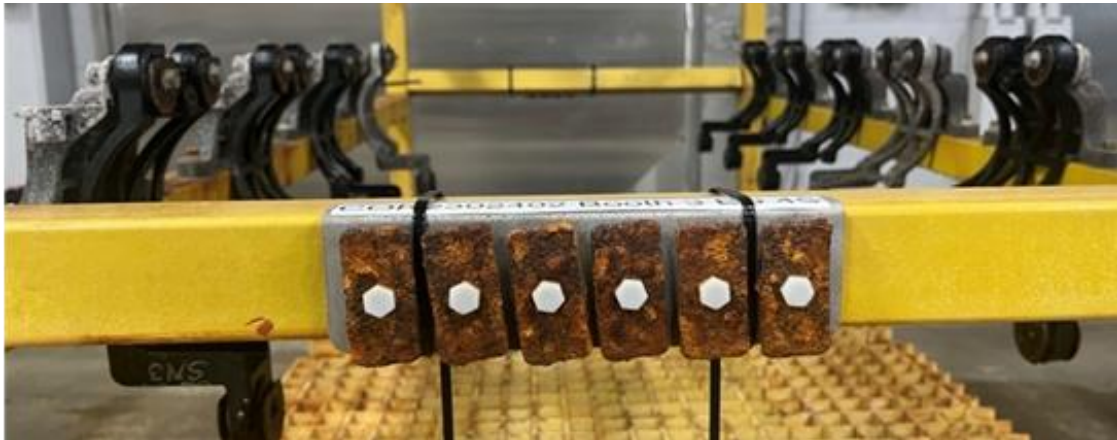
*Bare Steel Coupons correlate General Corrosion Mechanism to the Field*

- 10-15 years of general corrosion in just a few months
- 95<sup>th</sup> percentile environment (eg: Montreal)
- Correlated & controlled using **mass loss** of bare steel coupons
  - Salt Sprays & Mass Loss Targets vary per vehicle area / mounting location

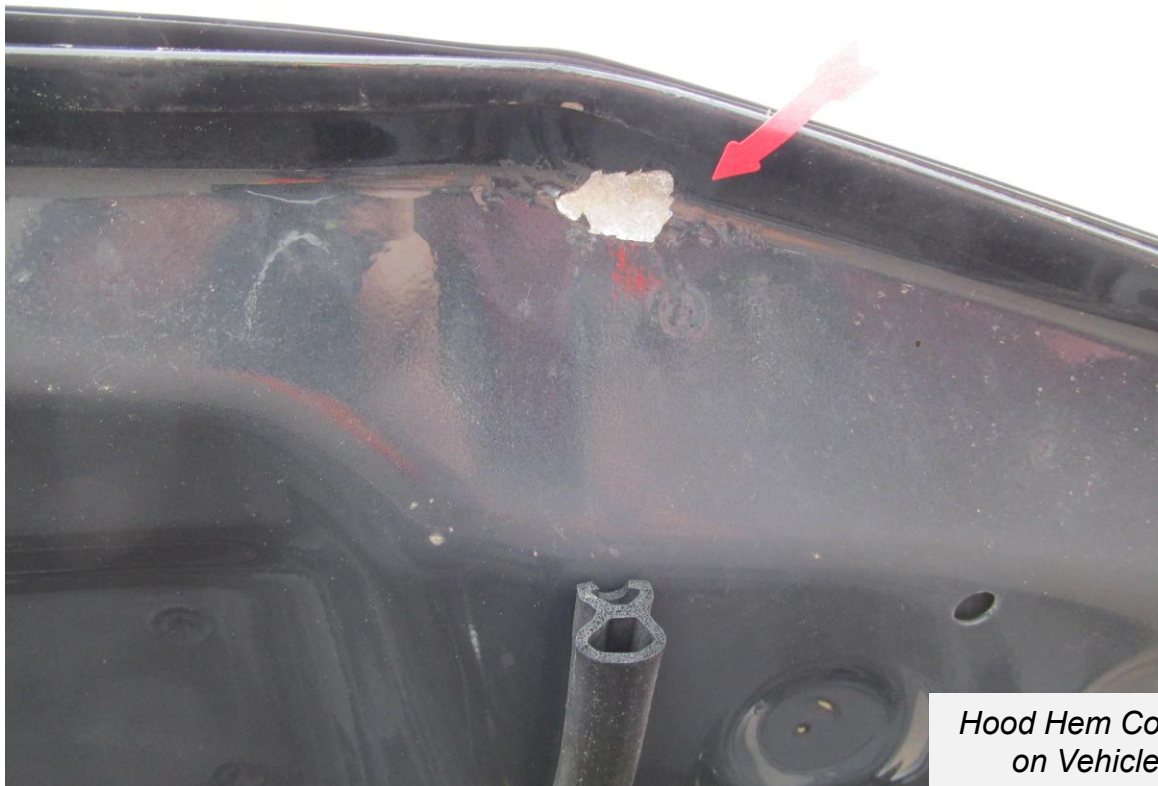
*Hood Hem Corrosion observed  
on Vehicle Field Survey*
